Contract #: 04-0120F4Cty: SF/ALA Rte: 80 PM: 13.2/13.9File #: 69.28**WELDING INSPECTION REPORT****Resident Engineer:**Siegenthaler, Peter**Address:** 333 Burma Road**City:** Oakland, CA 94607**Report No:** WIR-017920**Date Inspected:** 05-Nov-2010**Project Name:** SAS Superstructure**OSM Arrival Time:** 1900**Prime Contractor:** American Bridge/Fluor Enterprises, a JV**OSM Departure Time:** 700**Contractor:** Zhenhua Port Machinery Company, Ltd (ZPMC), Changxing Island **Location:** Shanghai, China**CWI Name:** See Below**CWI Present:** Yes No**Inspected CWI report:** Yes No N/A**Rod Oven in Use:** Yes No N/A**Electrode to specification:** Yes No N/A**Weld Procedures Followed:** Yes No N/A**Qualified Welders:** Yes No N/A**Verified Joint Fit-up:** Yes No N/A**Approved Drawings:** Yes No N/A**Approved WPS:** Yes No N/A**Delayed / Cancelled:** Yes No N/A**Bridge No:** 34-0006**Component:** OBG**Summary of Items Observed:**

On this date CALTRANS OSM Quality Assurance (QA) Inspector, Mr. Paul Dawson, arrived on site at the Zhenhua Port Machinery Company (ZPMC) facility at Changxing Island, in Shanghai China, for the purpose of monitoring welding and fabrication of the San Francisco /

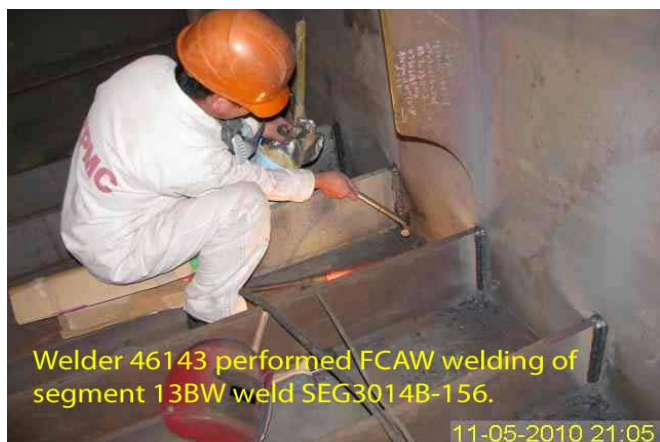
This QA Inspector observed ZPMC welder Mr. Xu Fubao, stencil 200569 used shielded metal arc welding procedure specification WPS-B-P-2211-B-U2-FCM-1 to complete tack welds between OBG segment 13BW deck plate DP3137-001(PL333A and PL333B) groove weld. This QA Inspector observed Mr. Xu Fubao appeared to be certified to make this weld and the base materials were preheated prior to welding. This QA Inspector measured a welding current of approximately 150 amps. Items observed on this date appeared to generally comply with applicable contract documents.
